## Lead Cable Investigation

June 01, 2023

MTS traveled to the agreed upon locations and surrounding communities with the WSJ to investigate the permit locations for presence of lead sheathed cables. Documentation as to the presence and condition of the lead sheathed cables was collected at each identified location using Fulcrum, data management software provided by Below the Blue (BtB), a not-for-profit organization.

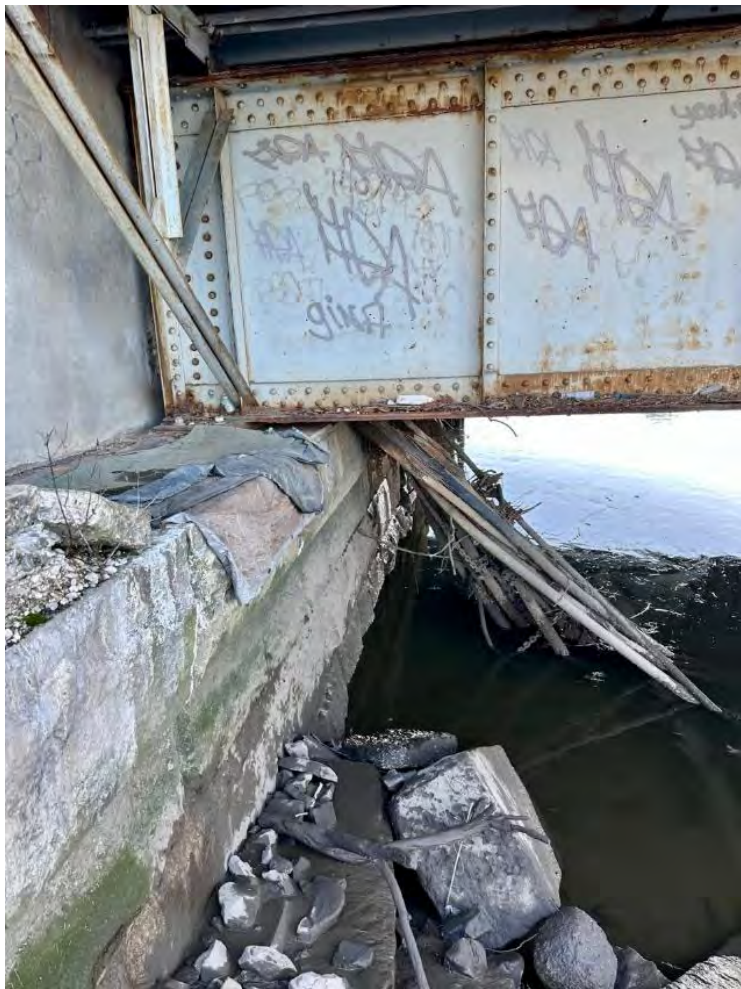
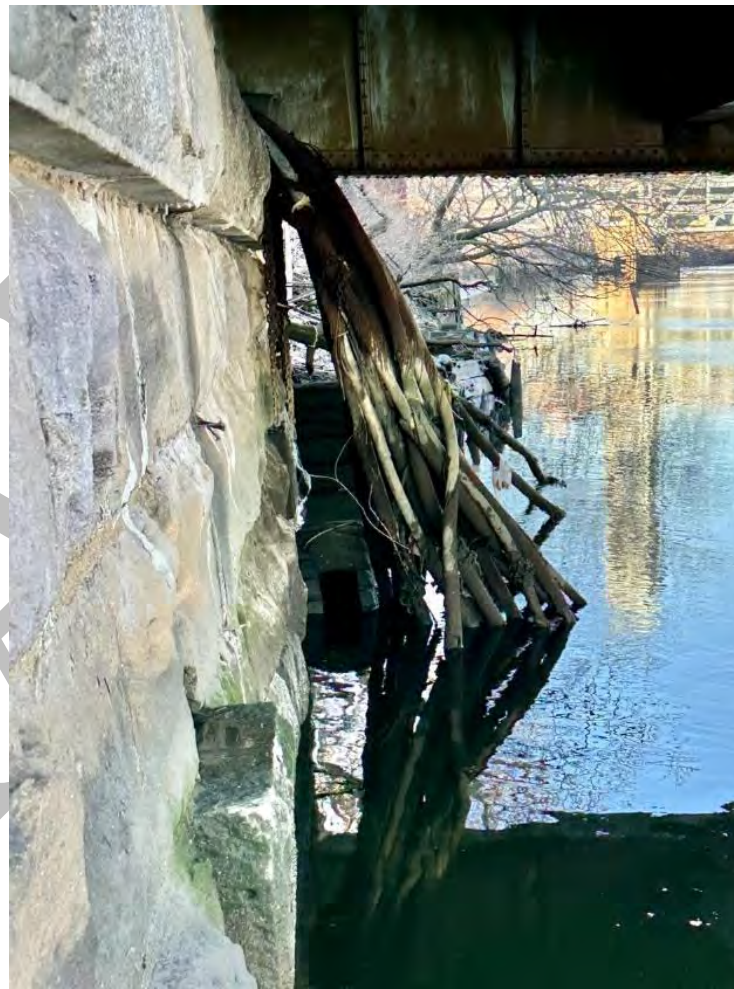
Figure 18. Photos. New Jersey continued. Cable location with twenty leaded cables underneath the Bridge Street Bridge (Harrison Ave). Evidence of homeless sleeping next to these cables along the Passaic River (Left). Passaic 2. January 2023, Harrison/University Heights, New Jersey.

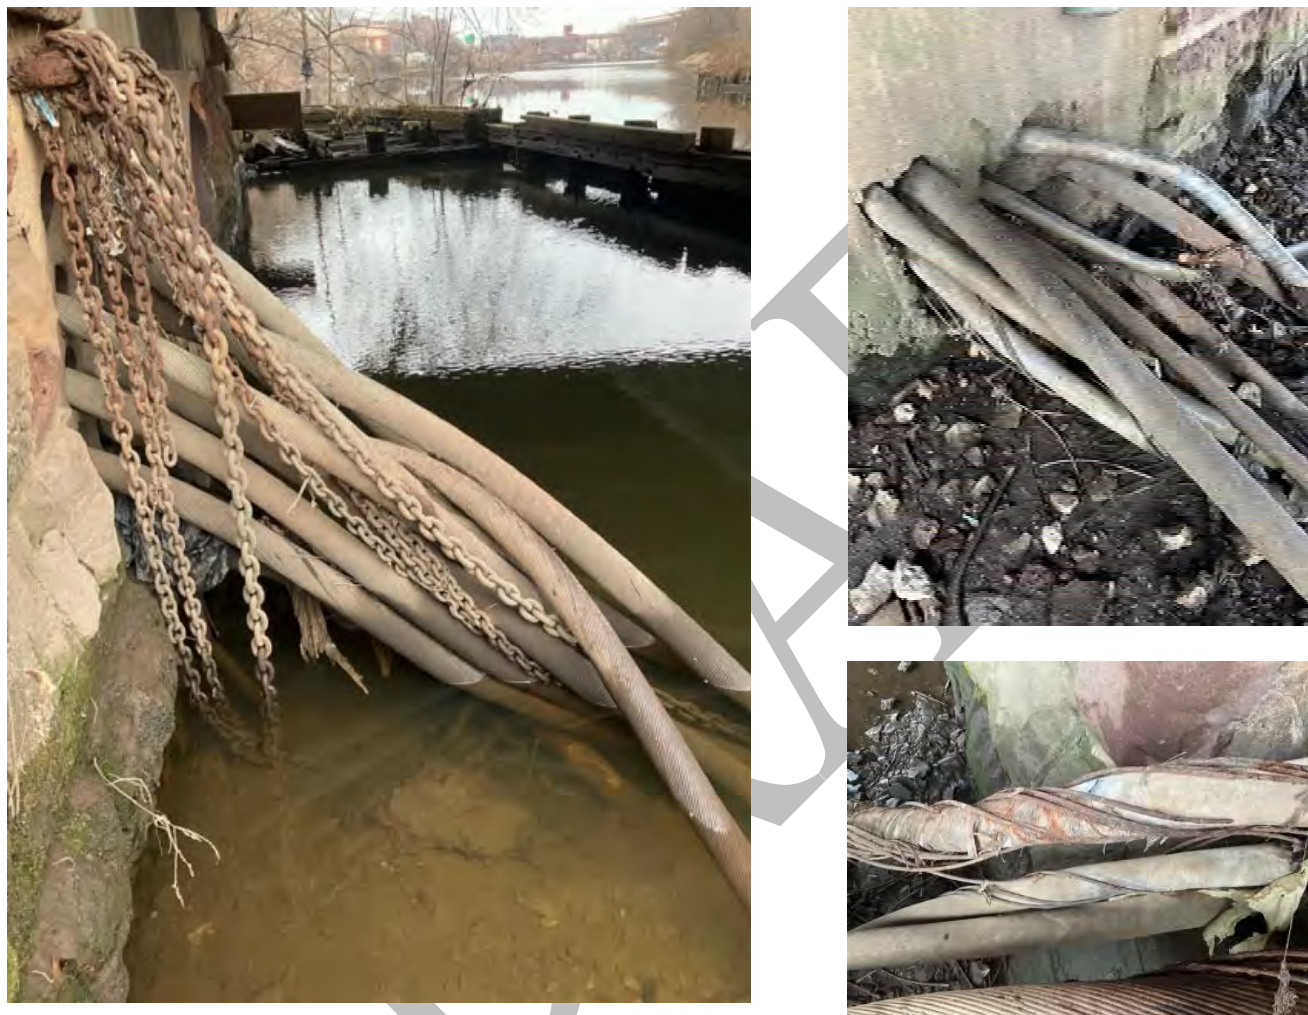
Figure 19. Photos. New Jersey continued. Cable location with approximately twenty-one exposed leaded cables underneath the Main Avenue Bridge near Wallington, New Jersey. This was a complex site with cables in multiple locations. Passaic Location 5, which includes twelve points of interest. January 2023, Wallington, New Jersey.

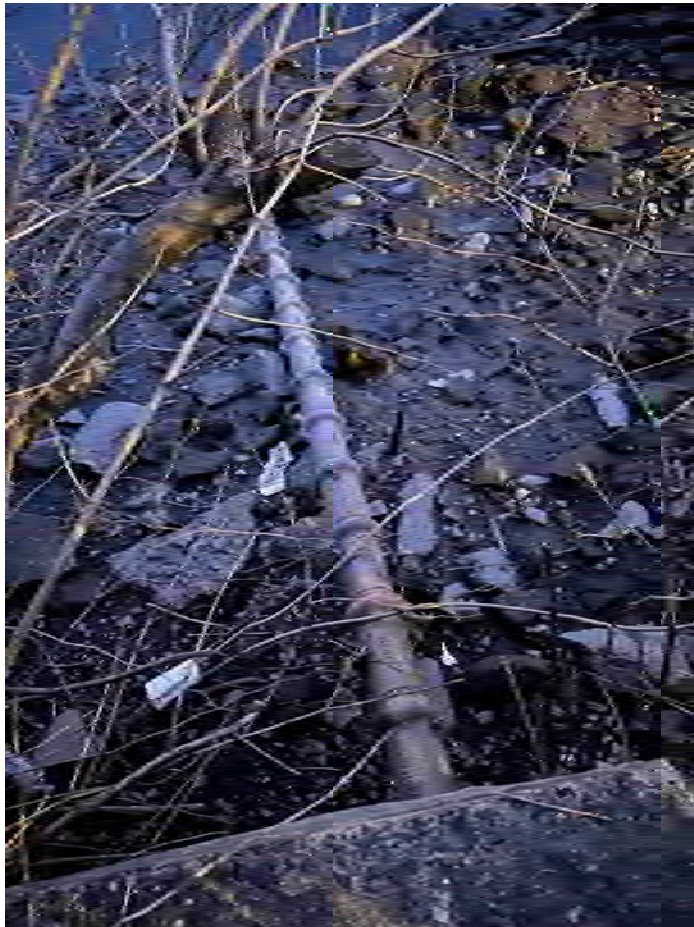
(A) Armored cable approximately fifteen feet from the water's edge. Passaic 3. January 2023, Belleville, New Jersey. .

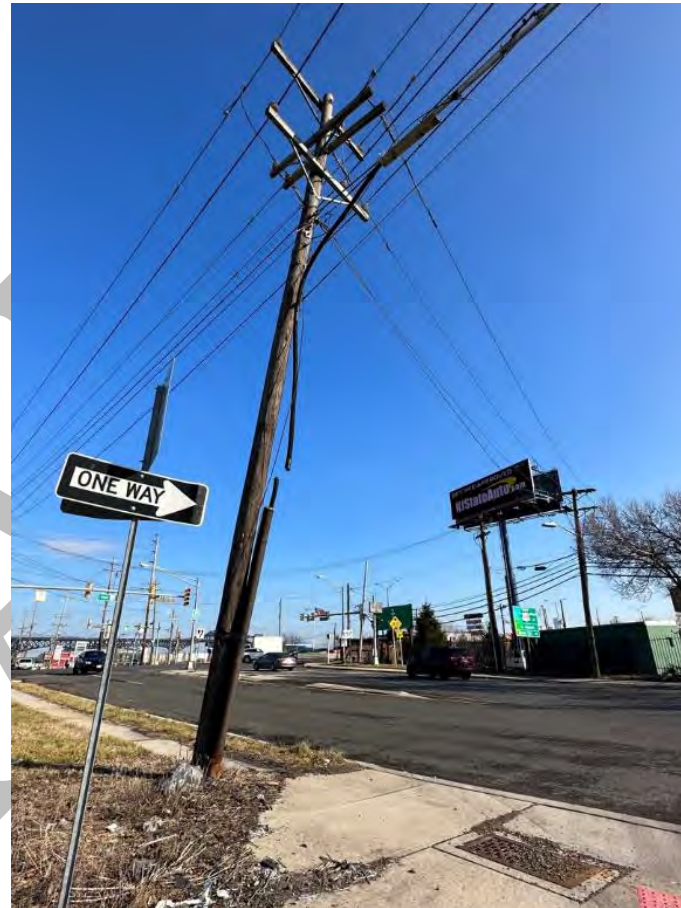
(B) Overhead cut, leaded cables in the South Kearny area. There are two cables that run approximately 0.4 miles. South Kearny End A. January 2023, Kearny, New Jersey.

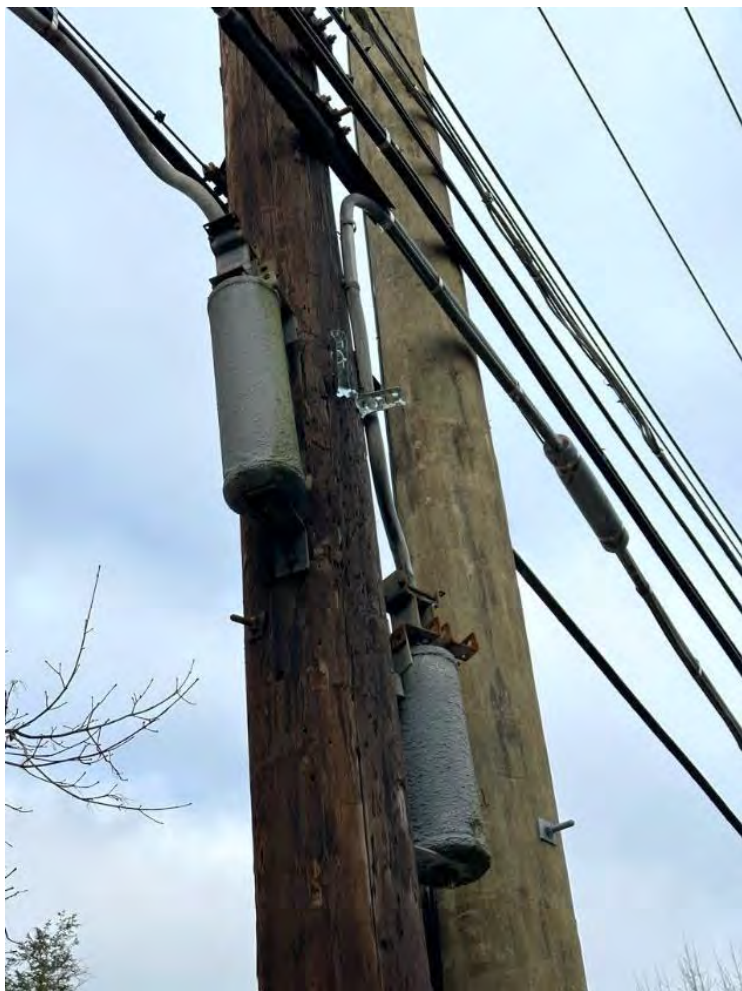
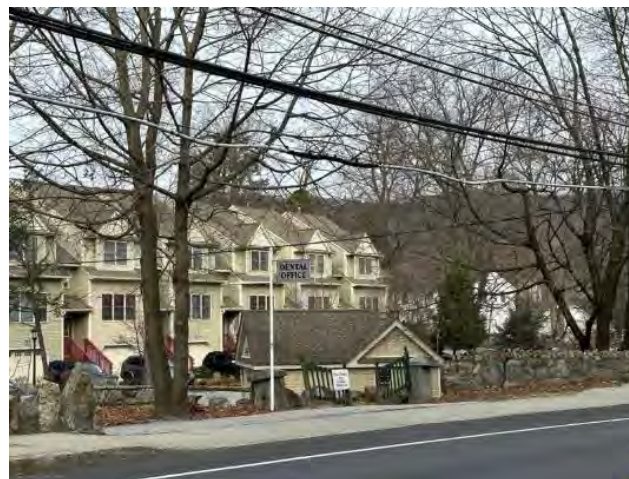
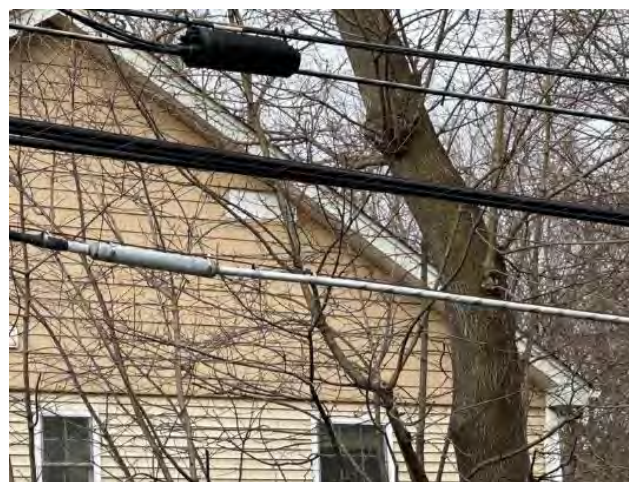
Figure 21. Photos. New York. Overhead leaded cables with splice boxes. Highland Falls Township. Highland Falls 1. January 2023, Highland Falls, New York.

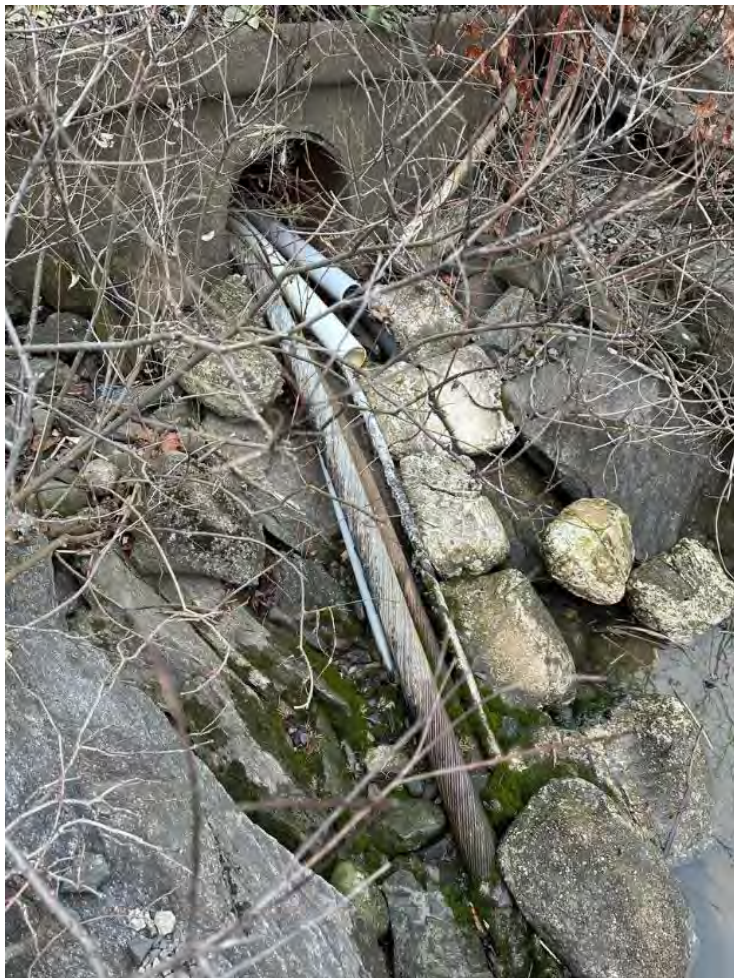
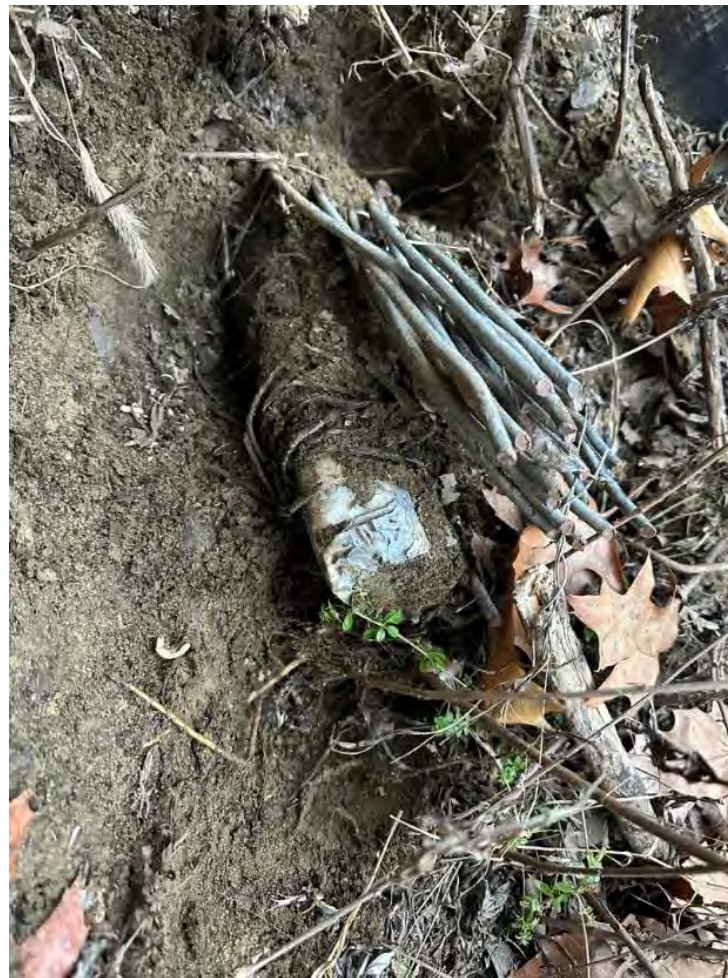
**Figure 22. Photos. New York continued. Left: Cables run under the road and into the Hudson River at Point of Interest: Hudson 3.1. Right: Severed cable and steel wire at the base of an old telephone pole, across from those pictured in the left image. Point if Interest: Hudson 3.4. January 2023, Near the Mid-Hudson Bridge, Highland, New York.**

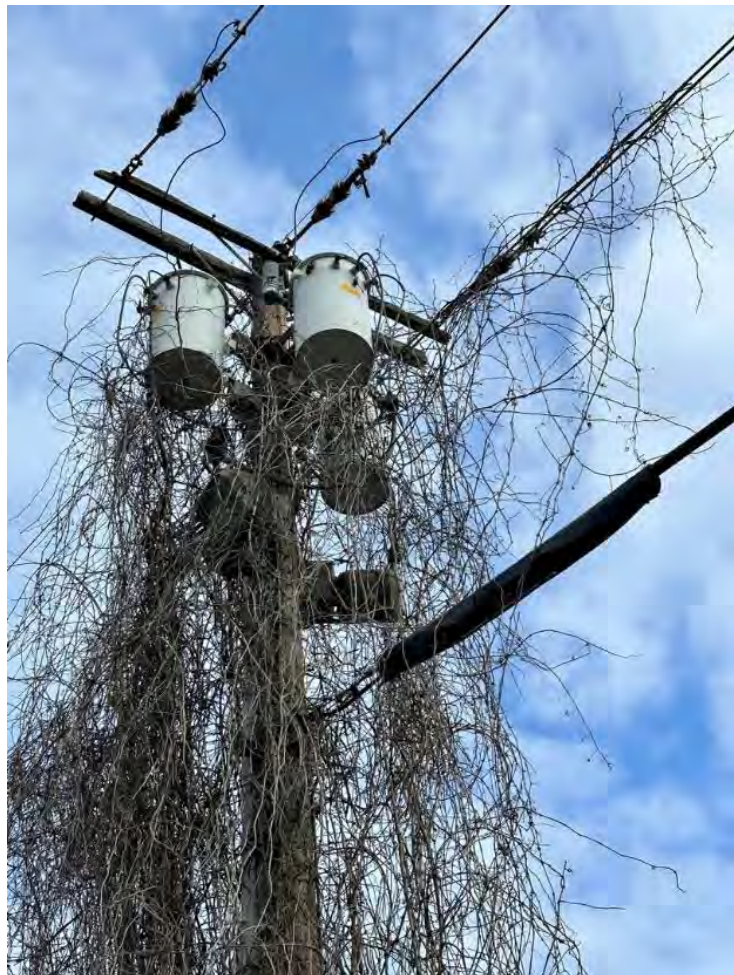
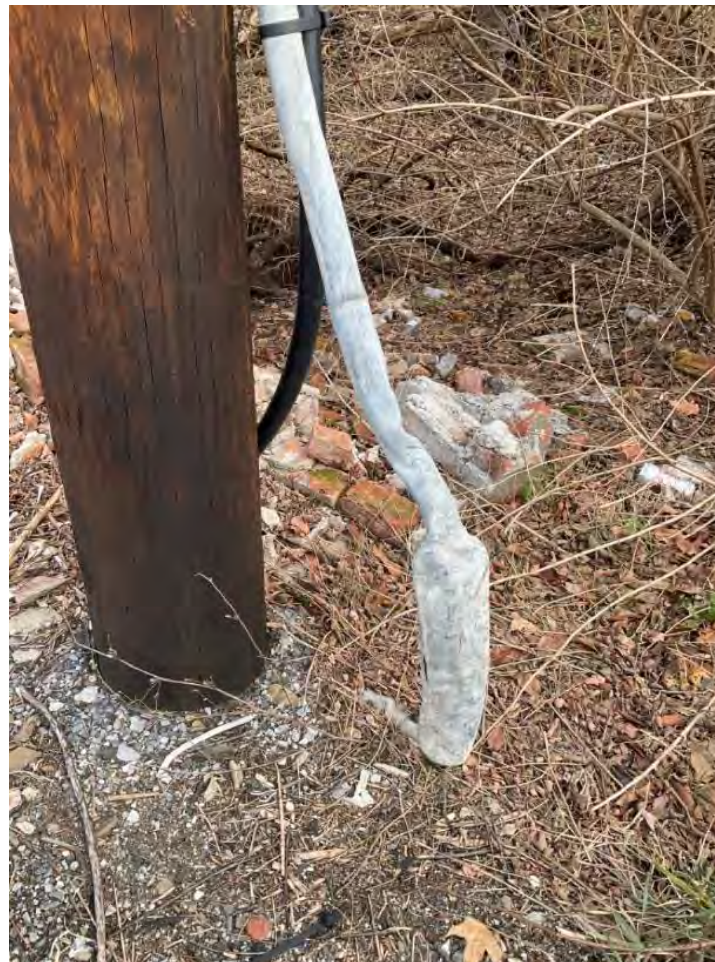
Figure 23. Photos. New York continued. Left: "Squirrel Guard" tied around an exposed area of lead cable. Point of Interest: Newburgh 1. January 2023, Newbury, New York. Right: Damaged lead cable and splice box at the base of an old telephone pole. Point of Interest: New Windsor 1. January 2023, New Windsor, New York.

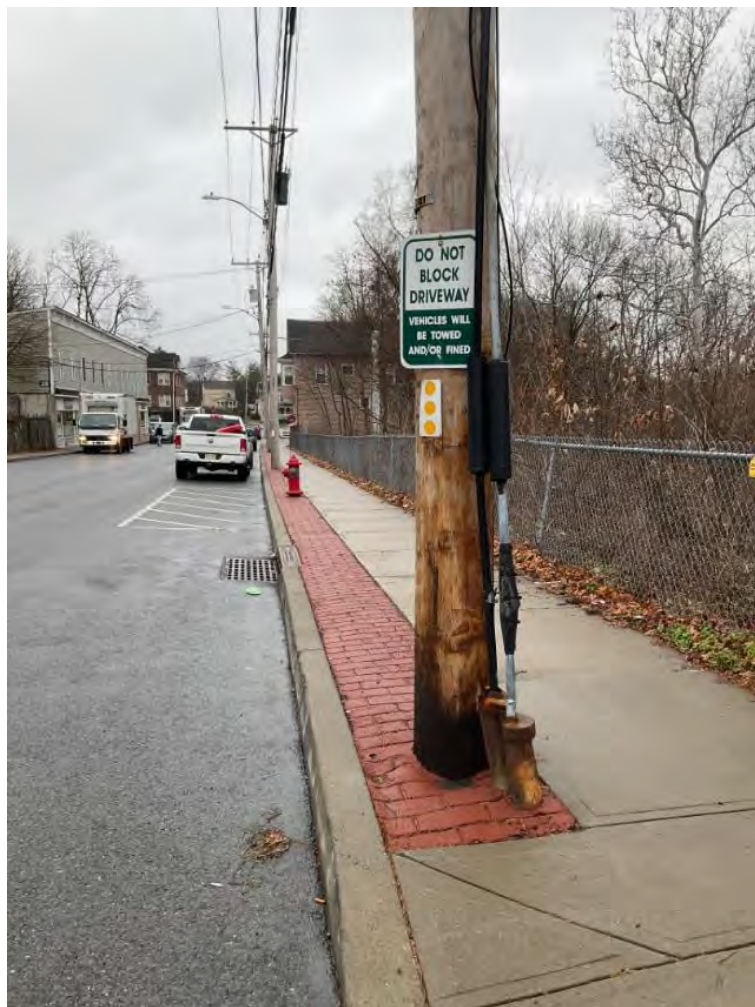
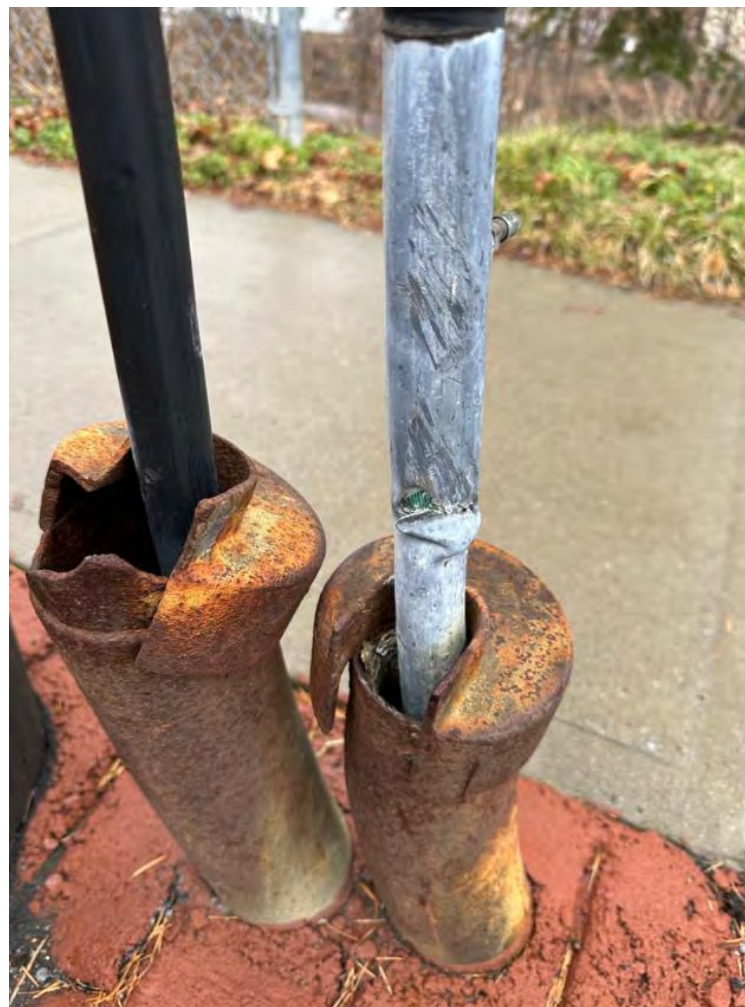
Figure 24. Photos. New York continued. Damaged lead sheathed cable at the base of a telephone in Wappingers Falls. Point of Interest: Wappingers Falls 3. January 2023, Wappingers Falls, New York.

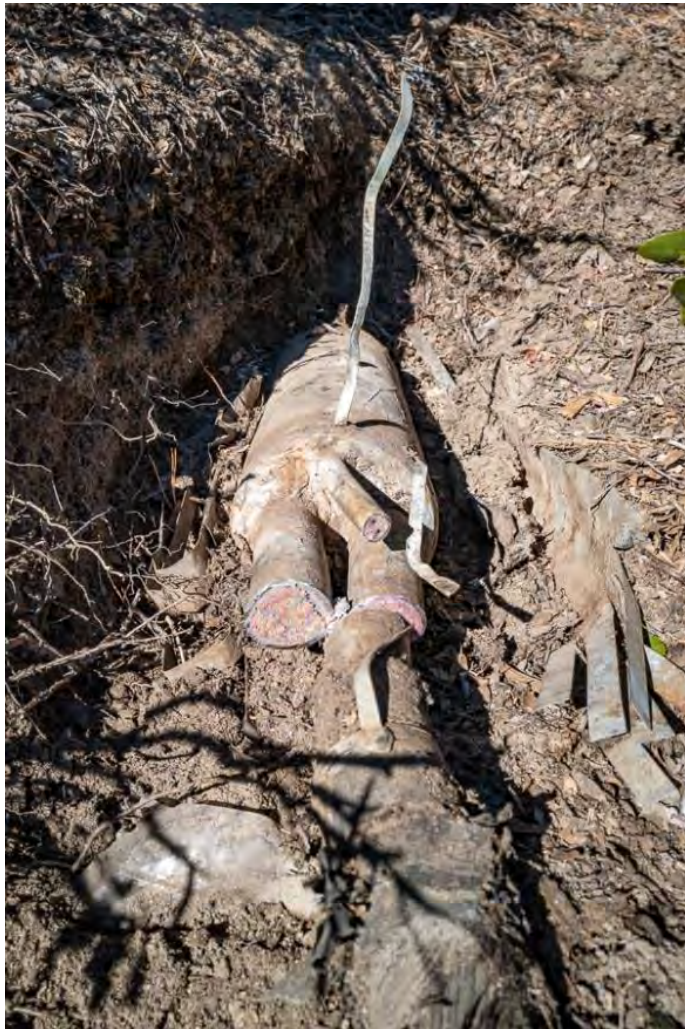
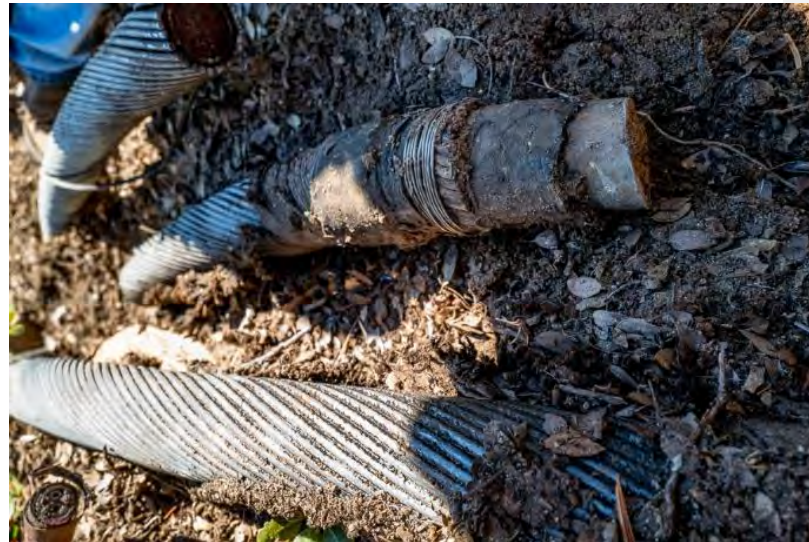
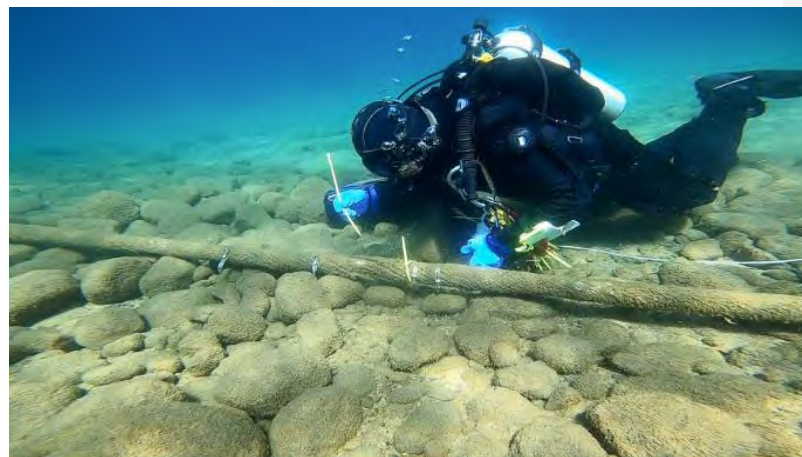
Figure 25. Photos. California. Lake Tahoe main telecommunications cable. LEFT: Severed cables, lead splice box on land. This photo was during a site visit with AT&T in January 2021. Top, RIGHT: Another splice location from land during the same site visit with AT&T in January 2021. RIGHT BOTTOM: Diver marking locations of damage during a survey in April/March 2022, Lake Tahoe, California.

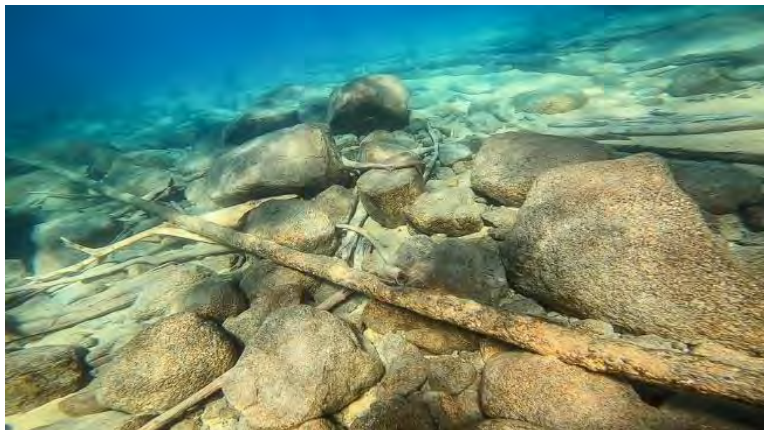
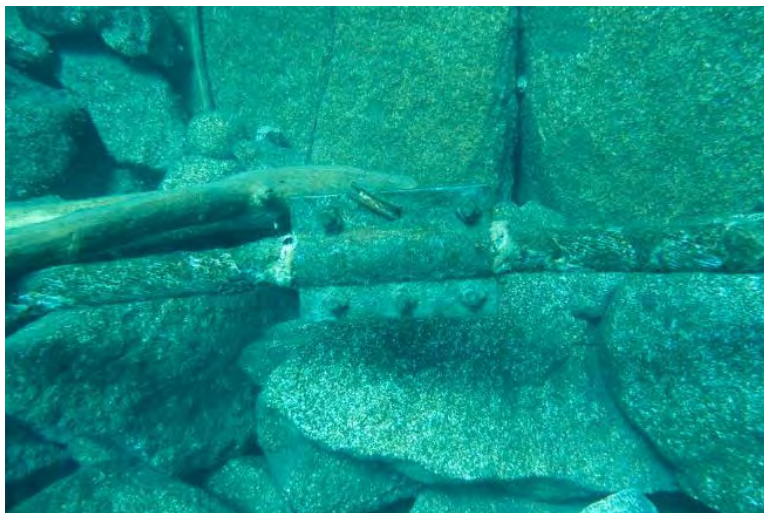
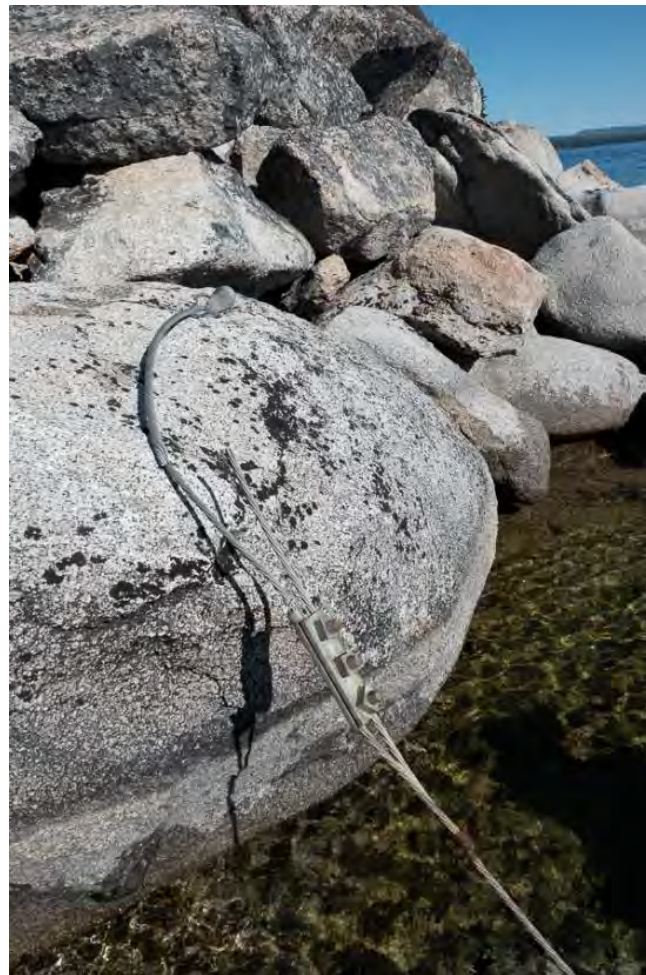
Figure 26. Photos. California continued. Cable laying among boulders on the lake bottom (Top Left). Part of a broken anchor on the cable near Rubicon (Bottom Left). Broken cable anchor on land near Rubicon (Right). All photos from survey in April/March 2022, Lake Tahoe, California.

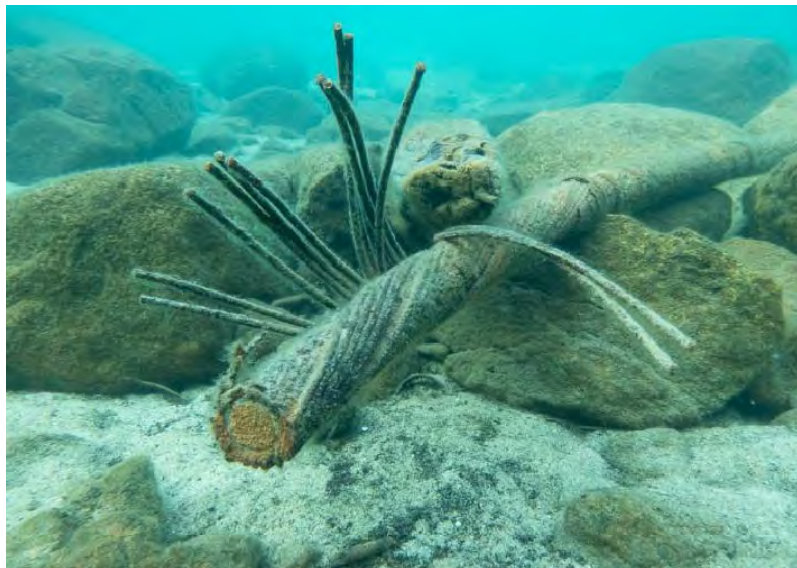
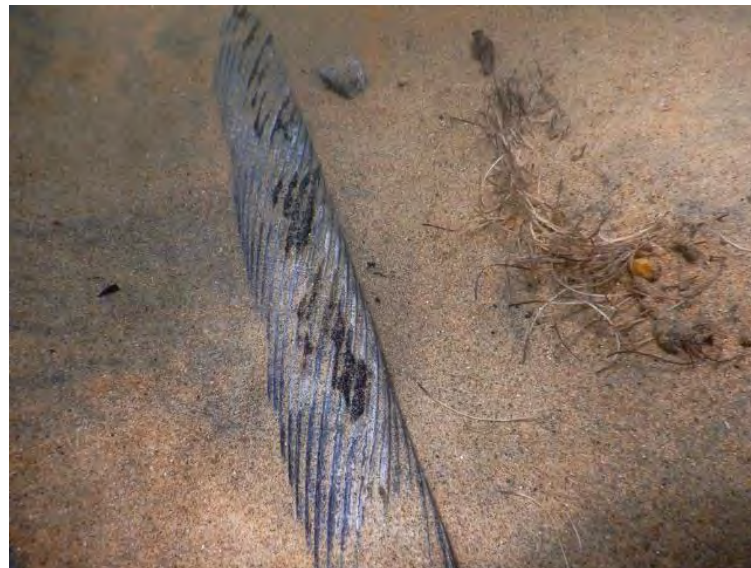
Figure 27. Photos. California continued. Severed end of 1920's cable in Emerald Bay (Left). 1920's Cable resting on the lake bottom in Emerald Bay (Right). May 2021, Emerald Bay – Lake Tahoe, California.
